Manhole Inspection Summary

Manhole # S2901_029MH

Insp Date: **2/19/08 10:05 AM**

Location Address: **2718 Carver Rd.**

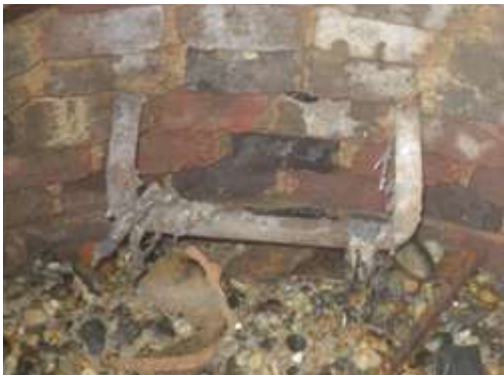
Step

Steps Count: **1** Missing: **0** ☒ **Corroded**

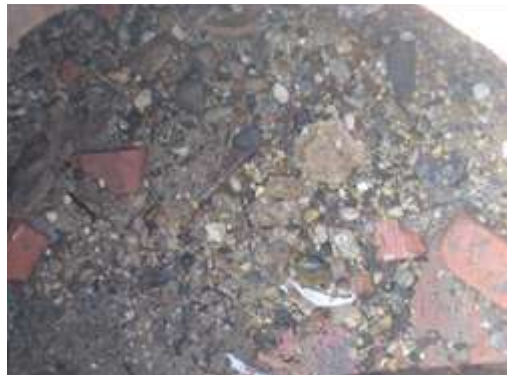
Defect 1

Condition: ☐ Sound ☐ Cracked ☐ Root Intrusion ☐ Deteriorated ☐ Leaks ☒ **Debris**

Heavy debris on bench

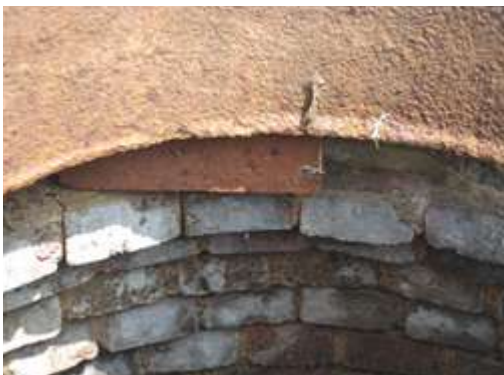
Defect 2

Condition: ☐ Sound ☐ Cracked ☐ Root Intrusion ☒ **Loose Brick** ☐ Deteriorated

Loose bricks in chimney

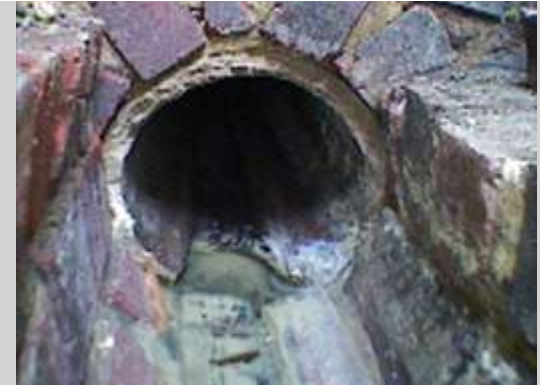
12 O'Clock Outflow

8 in. Circular Gravity Sewer
Pipe Out @ 12 O'Clock

Pipe Height: **9.6** (in.) Rod and Bar (Angled)
Pipe Material: **Clay** ☐ Pipe Lined
Invert Depth: **4.37** (ft.) Flow Characteristics: **Fast**
Deposits: ☒ None ☐ Mud ☐ Sludge ☐ Debris ☐ Grease
Silt Depth: (in.) Deposits Extent:
Infiltration: **None** Pipe Seal Cond: **Sound**

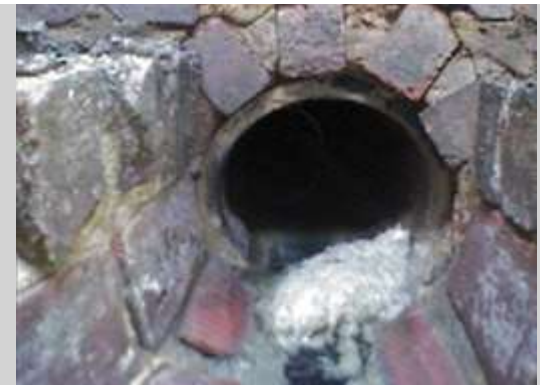
3 O'Clock Inflow

8 in. Circular Gravity Sewer
Pipe In @ 3 O'Clock

Pipe Height: **9.6** (in.) Rod and Bar (Angled)
Pipe Material: **Clay** ☐ Pipe Lined
Invert Depth: **4.10** (ft.) Flow Characteristics: **Fast**
Deposits: ☒ None ☐ Mud ☐ Sludge ☐ Debris ☐ Grease
Silt Depth: (in.) Deposits Extent:
Infiltration: **None** Pipe Seal Cond: **Sound**
